Home Inspection Report

BRETT HODGDON

413 WOODBRIDGE DRIVE
CHARLESTON, WV 25311

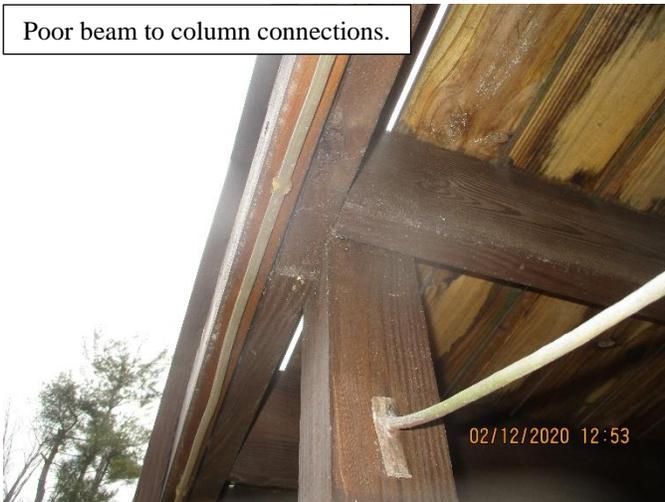
1. Major Concern: Various defects are present in the construction of the rear deck. Improper construction risks failure. An exhaustive review and analysis of the structure along with providing an itemized list of defects and specific recommendations for repair are outside the scope of a Home Inspection. Some of the observed defects have been depicted in photographs that follow. A qualified framing contractor should be engaged to perform the necessary repairs. Additional guidance can be provided upon request.

Poor beam to column connections.

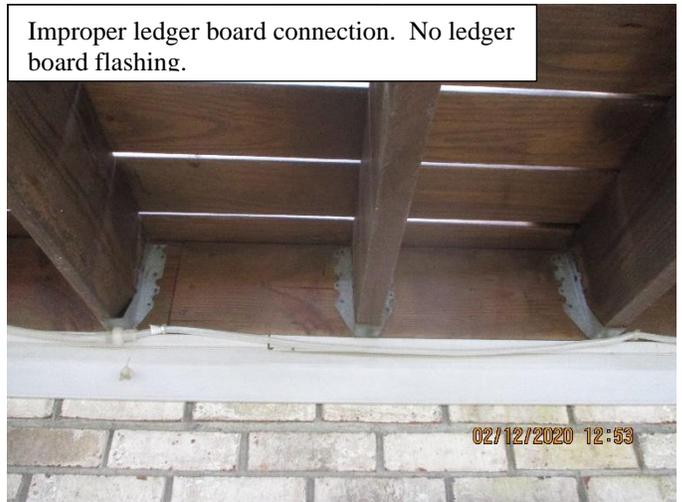
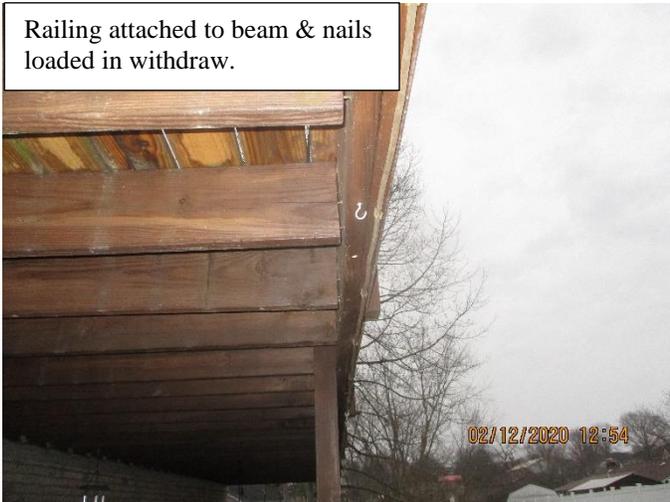
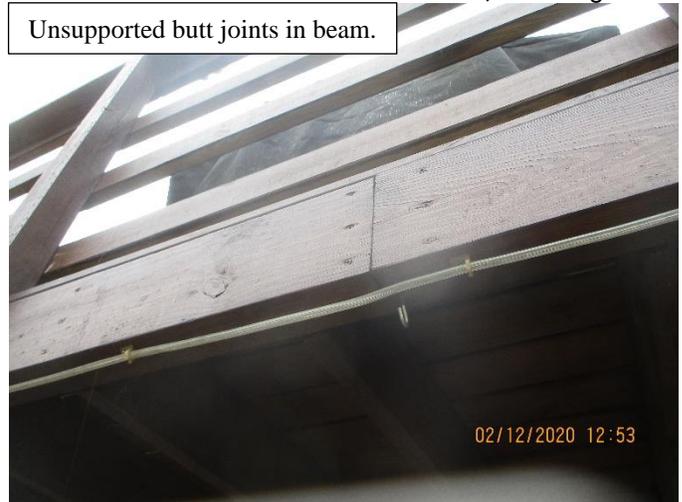
Improper ledger board connection. No ledger board flashing.

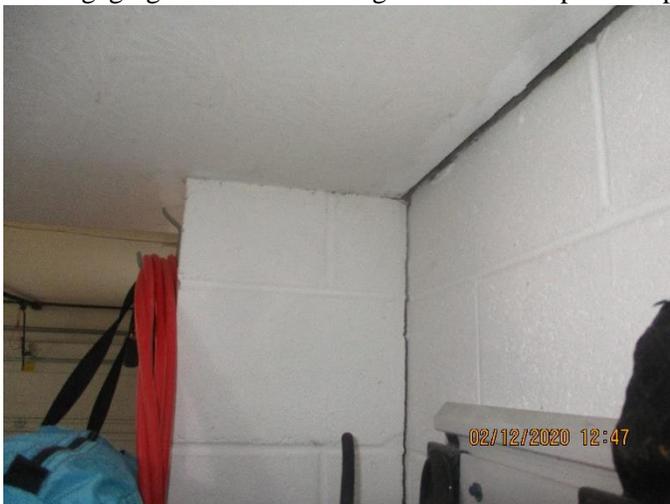
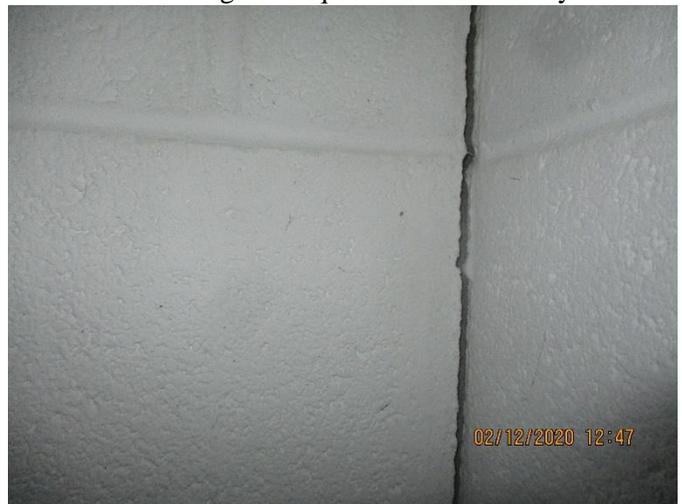
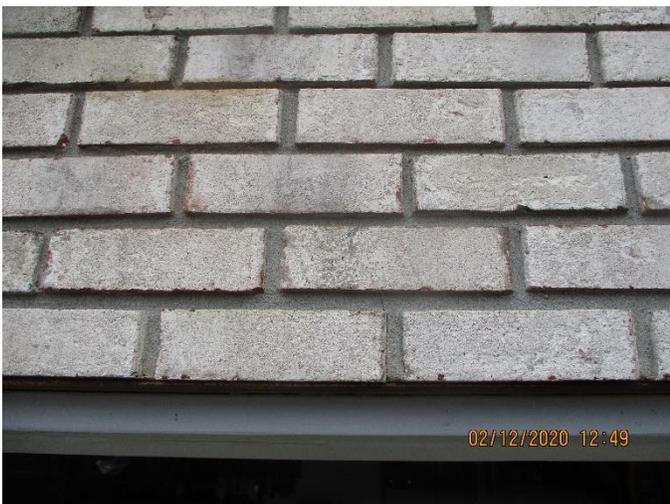
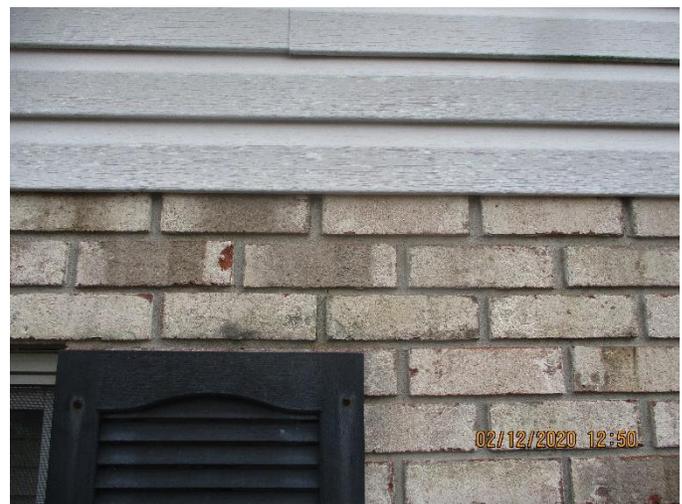
2. Monitor: Typical minor cracking was observed in various locations in the foundation walls and brick veneer. This implies that some structural movement of the building has occurred. Cracks of this type should be watched for signs of additional movement. In the absence of any ongoing movement, repair should not be necessary. Engaging a Professional Engineer to develop and implement a monitoring technique and schedule may be desired.

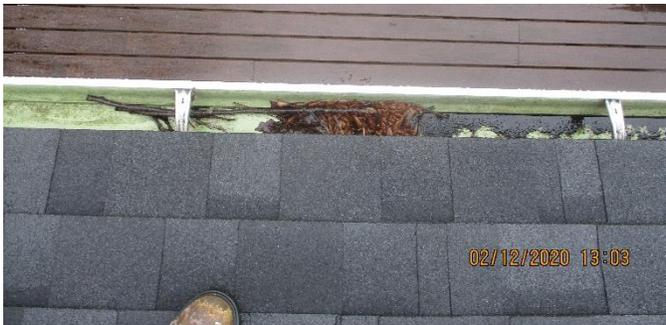
1. Repair: The gutters are congested with debris. They should be cleared and well maintained. It should also be verified that downspouts are clear and free draining. Improper control of roof runoff increases the potential for water entry and damage along, fungal growth, and foundation movement.

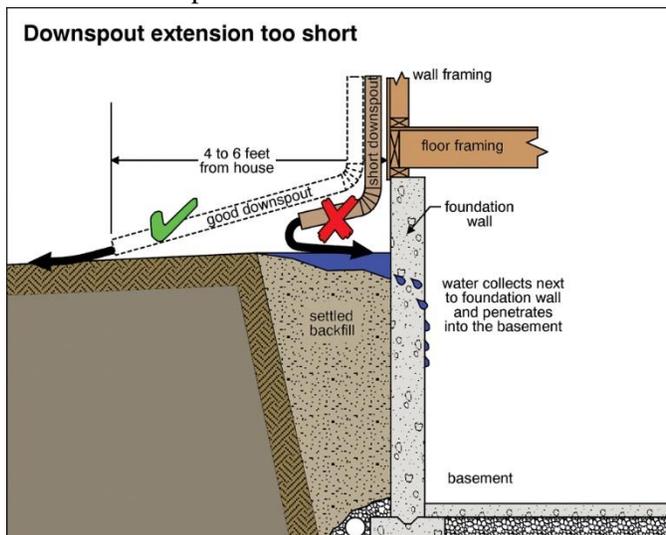
2. Repair: The downspout at the right front should discharge water at least five feet from the house. Storm water should be encouraged to flow away from the building at the point of discharge. Excess water around a foundation increases the potential for foundation movement as well as water entry and damage.

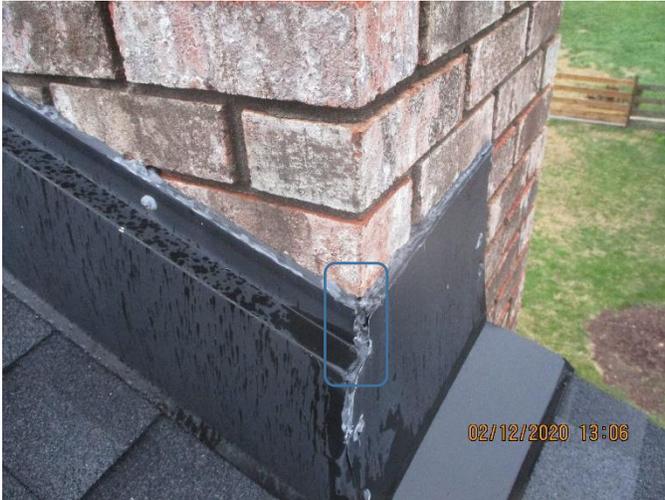
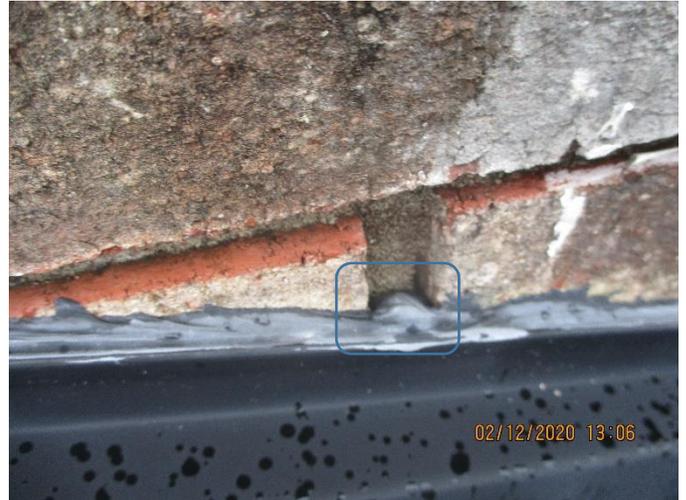
3. Repair: The counter flashing for the masonry chimney has simply been caulked to the side of the masonry. Gaps are present and the flashing is susceptible to allowing water leakage and damage. In addition, this seal is susceptible to failure due to the constant thermal expansion and contraction of the different materials. Ideally, the counter flashing would have been let into and secured and sealed within the brick veneer. At a minimum, the caulk would be touched up and well maintained.

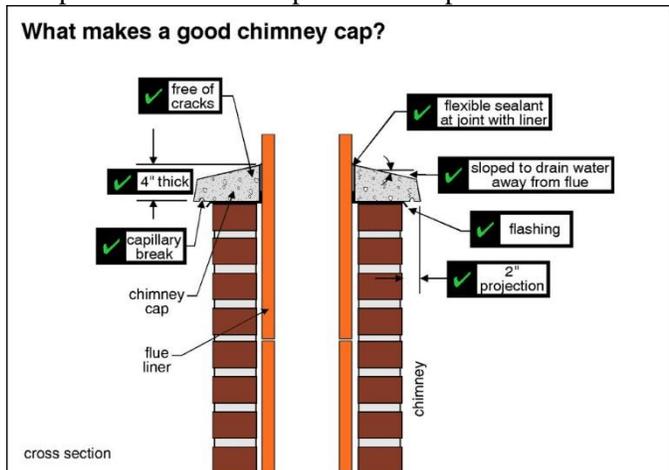
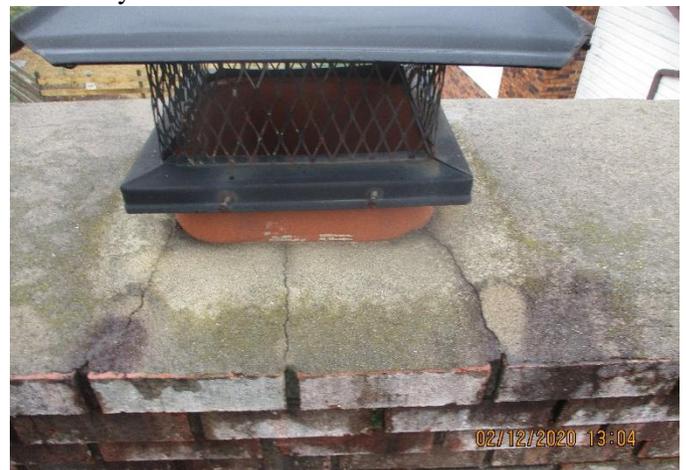
4. Repair: The crown of the masonry chimney is cracked. At a minimum and as a temporary repair, all cracks and seams should be sealed to prevent ongoing water entry and damage. Ideally, the crown would be removed and replaced or a metal cap and screen provided for the entire chimney.

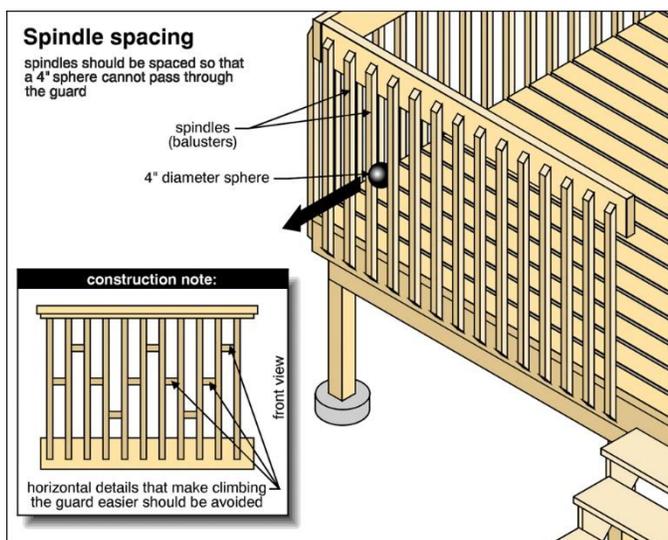
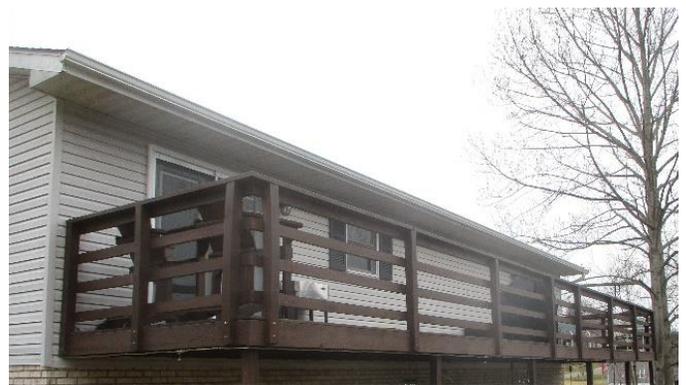
- Safety Issue:** Loose railings for the rear deck should be repaired or replaced by a skilled handyman or carpenter for improved safety.
- Safety Issue:** The openings in the guard railings for the rear deck are large enough and oriented in a way that a child could fall through the railing or use the railing as a ladder and climb up and over the railing. Modifying the railing is recommended.

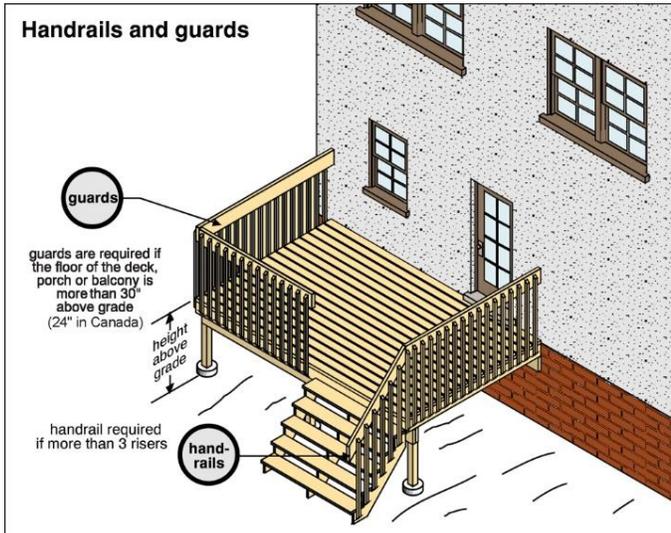
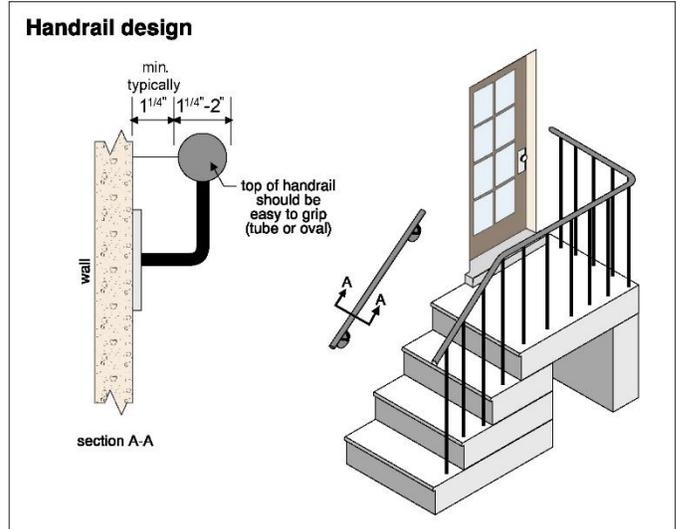
3. **Safety Issue:** Proper guard railings should be provided for the front porch and front porch stairway.
4. **Safety Issue:** The installation of a graspable handrail for the front porch stairway is recommended for improved safety.

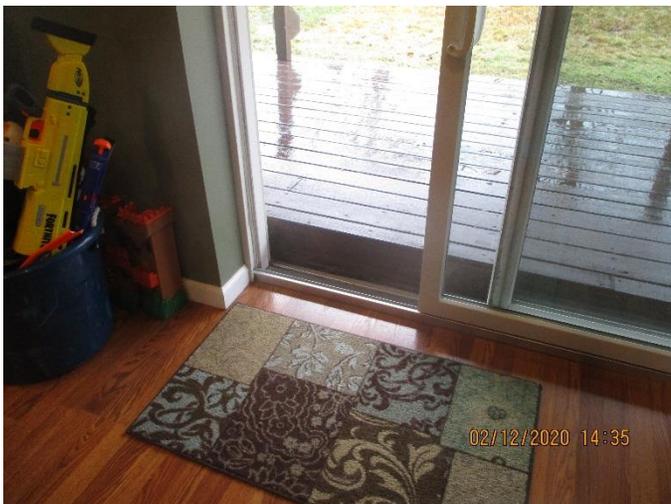
5. **Safety Issue:** The step up or down, depending on one's line of travel, at the exterior basement door is considered a tripping hazard. Ideally this condition would be modified.

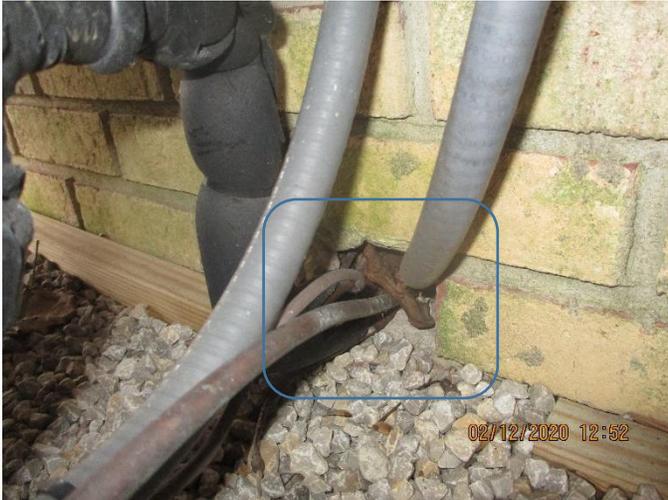
8. **Repair:** The opening where the refrigerant lines for the HVAC equipment pass into the house should be sealed to prevent water entry and damage.

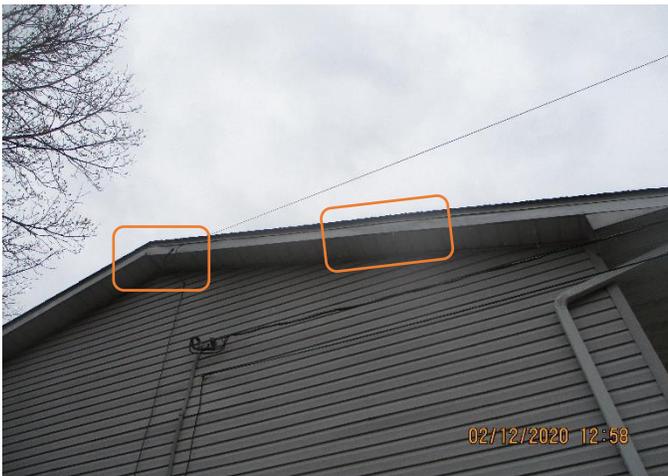
9. **Repair:** Loose soffit or fascia on the left side of the house should be secured.

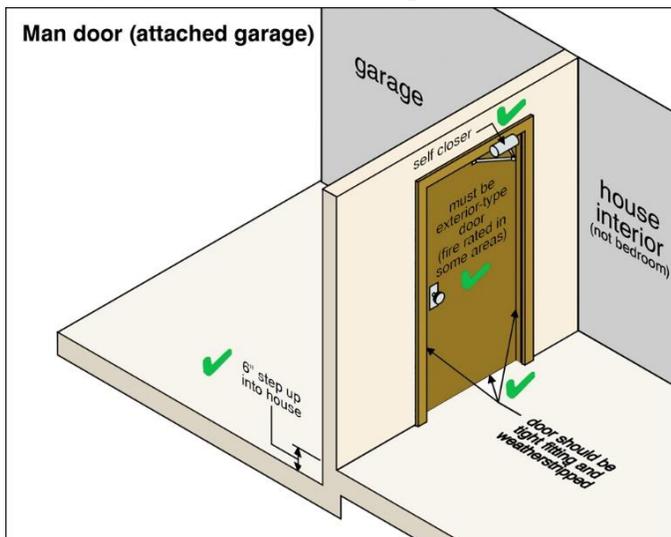
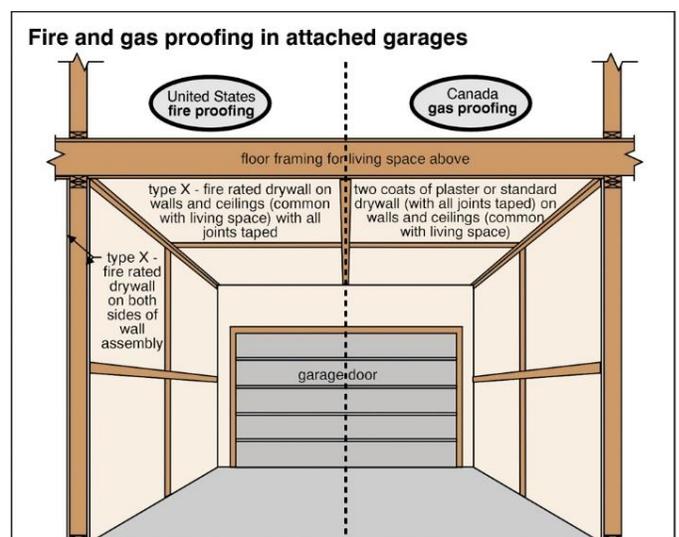
10. **Improve:** Gas and fire separation between the garage and interior of the house has not been provided. Upgrading the garage enclosure would improve safety.

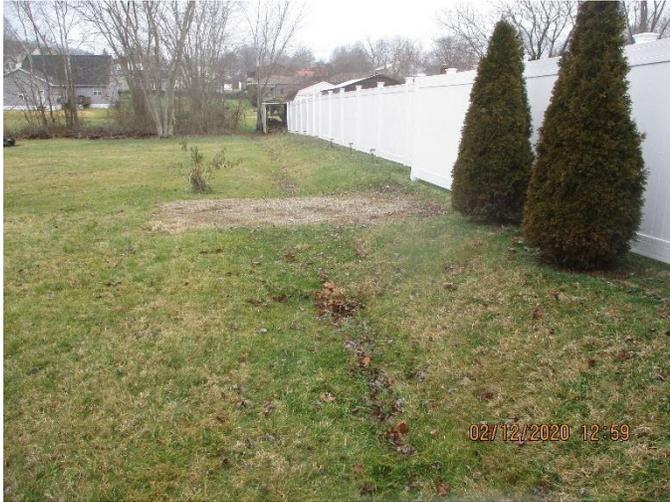
11.Improve: The drainage swale at the rear of the property has been modified preventing the flow of water.

Reestablishing the drainage swale is recommended to improve the control of storm water.

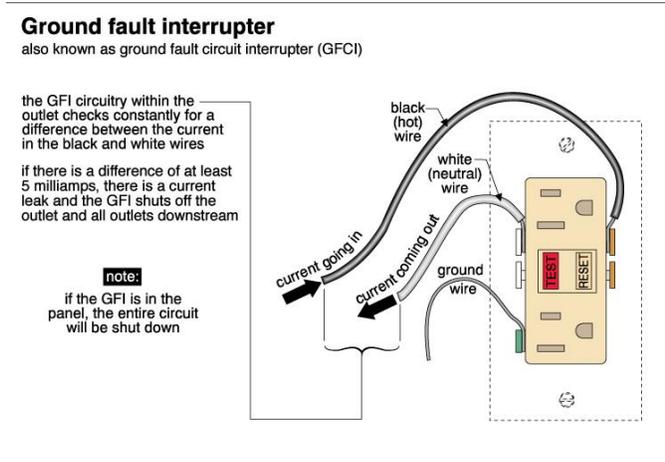
- 3. Safety Issue:** The installation of ground fault circuit interrupter (GFCI) protection for all of the outlets in the kitchen, garage, and laundry room is recommended. A GFCI offers increased protection from shock or electrocution.

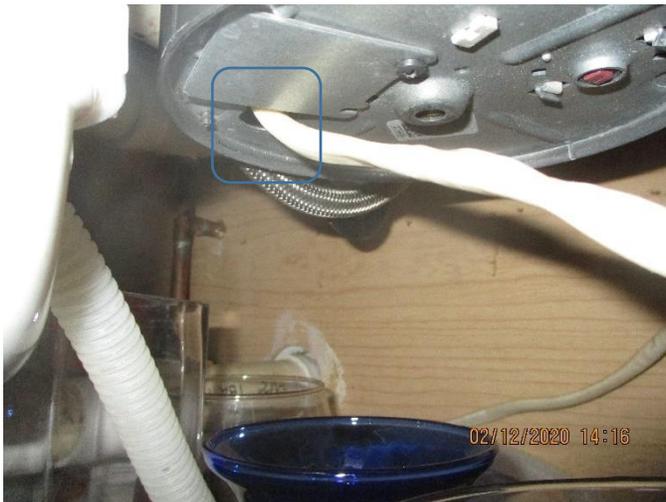
- 4. Repair:** The breakers for the main distribution panel should be labeled to ensure knowledge of where they service.
- 5. Repair:** The opening in the main panel should be covered. The duct tape is not considered an appropriate cover.
- 6. Repair:** Circuits within the main distribution panel that are doubled up (referred to as “double taps”) should be separated. Each circuit should be served by a separate breaker.
- 7. Repair:** Cable clamps (sometimes referred to as bushings or grommets) are required where wiring passes into electrical equipment. Cable clamps serve to protect the wiring from the metal edges of the panel openings. The missing clamp for the garbage disposal should be replaced.

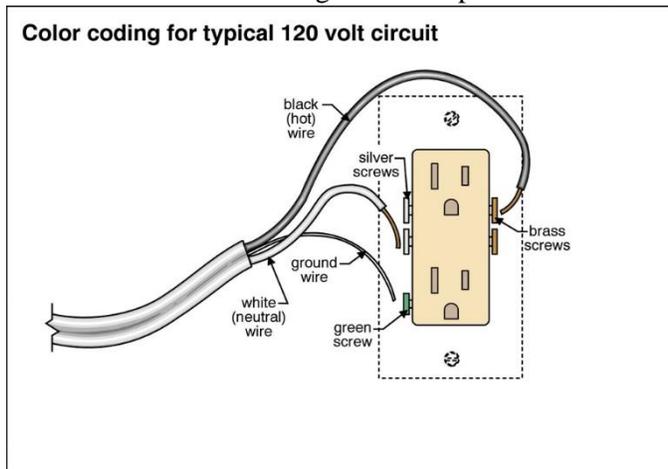
9. Repair: An ungrounded three-prong outlet is present at the rear of the main floor living room. This outlet and circuit should be investigated and repaired as necessary.

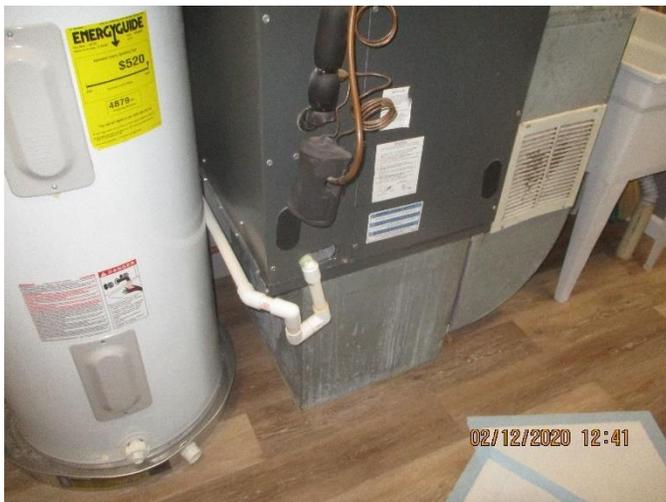
- 1. Repair:** No form of auxiliary condensate leakage protection has been provided for the heat pump. This can allow leakage and water damage in the event the condensate drain line becomes congested. A qualified HVAC technician should be engaged to perform the necessary repairs.

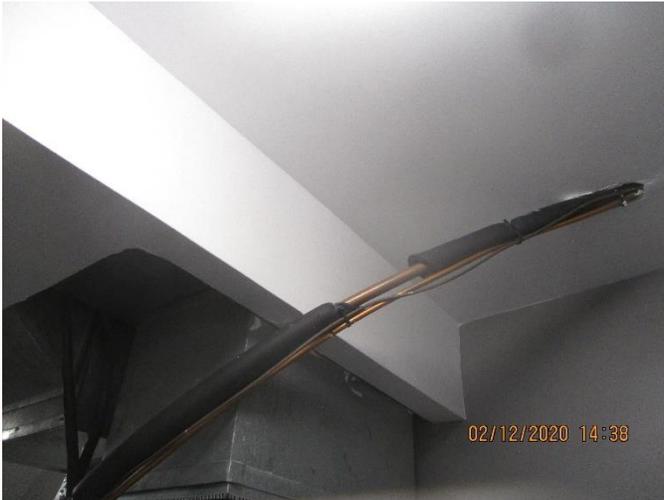
- 2. Repair:** Missing insulation on refrigerant line in the laundry room should be repaired to prevent the development of condensation.

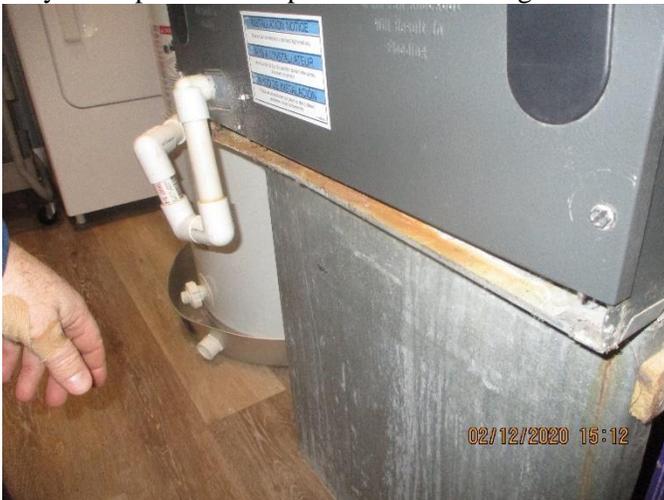
- 3. Repair:** Prior condensate leakage from the interior portion of the heat pump has occurred in the past. If the unit has not been service and this condition remedied, it should be done prior to the cooling season to ensure proper system operation and prevent water damage.

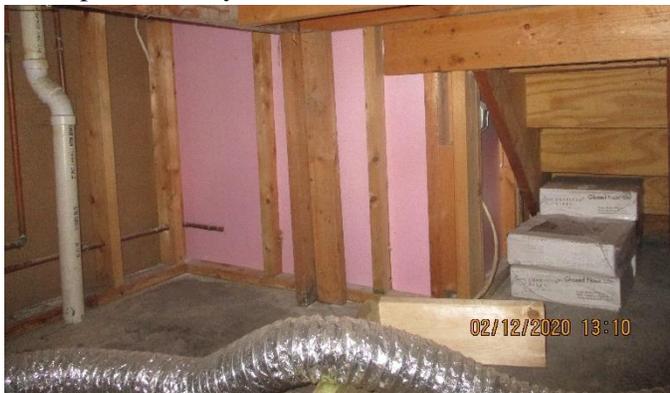
- 1. Safety Issue:** *The exposed foam board insulation in the closet below the basement stairway represents a fire hazard.* Although this is a common occurrence, it is recommended that this insulation be removed or covered for improved safety.

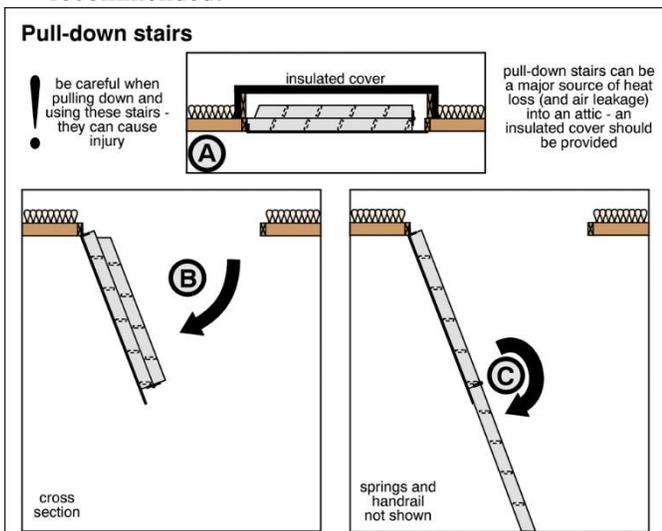
- 2. Improve:** The installation of weather stripping and an insulated cover for the drop ladder stairway is recommended.

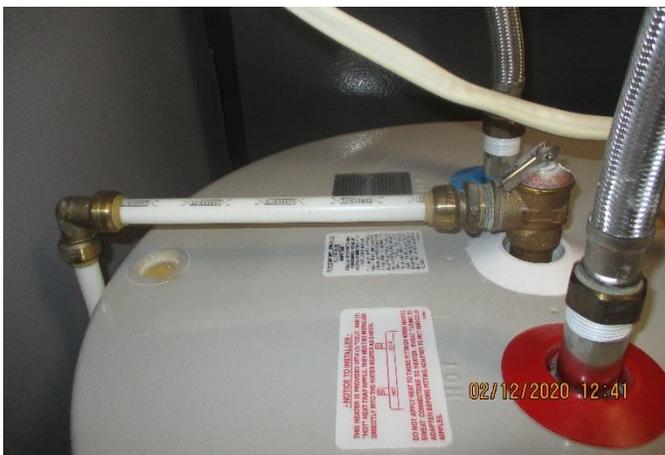
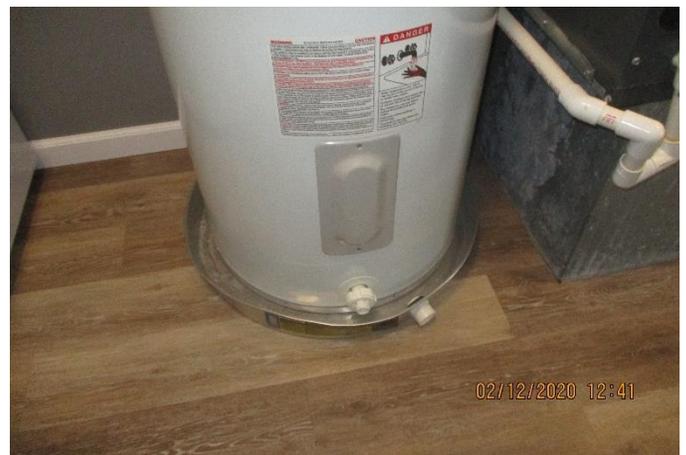
- 3. Repair:** The discharge piping for the water heater's temperature and pressure relief (TPR) valve has been sized down. In other words, the piping is undersized. This increases the potential for the improper discharge of hot water in the event the water heater malfunctions and the TPR valve releases water. Replacing the discharge piping is recommended.

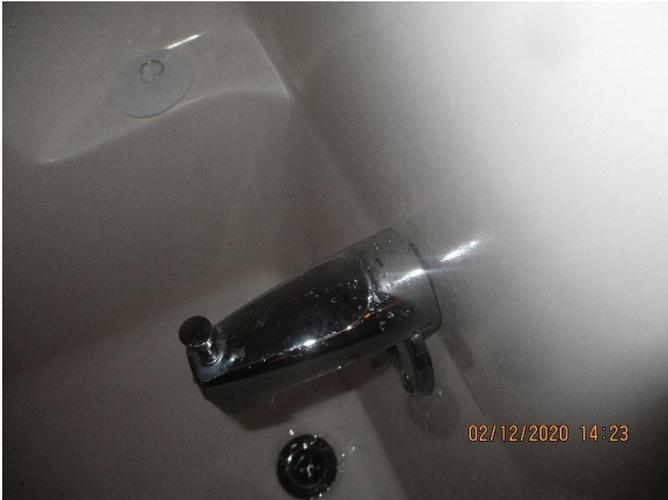
4. **Repair:** The faucets for both bathtubs are leaking and difficult to operate. They should be repaired or replaced as required by a plumbing contractor.
5. **Repair:** The finish surface of the master bathtub is chipped in multiple locations. It does not appear that this condition is allowing leakage to occur. The fixture should be patched to prevent progressive deterioration.
6. **Repair:** The penetration for the faucet in the master bathtub is vulnerable to allowing water leakage and damage. This penetration should be improved as required.

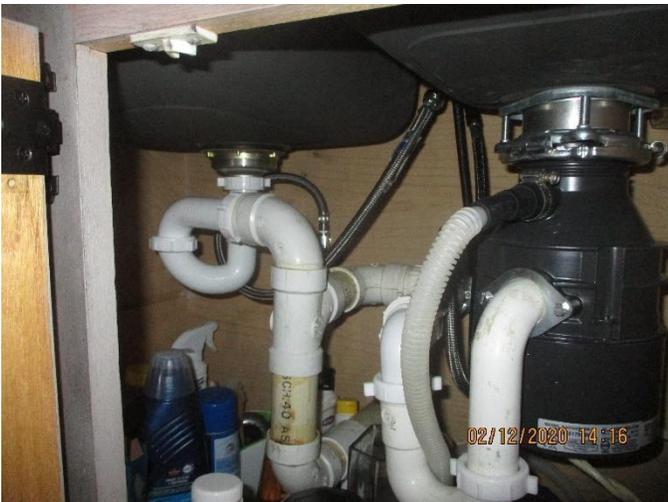
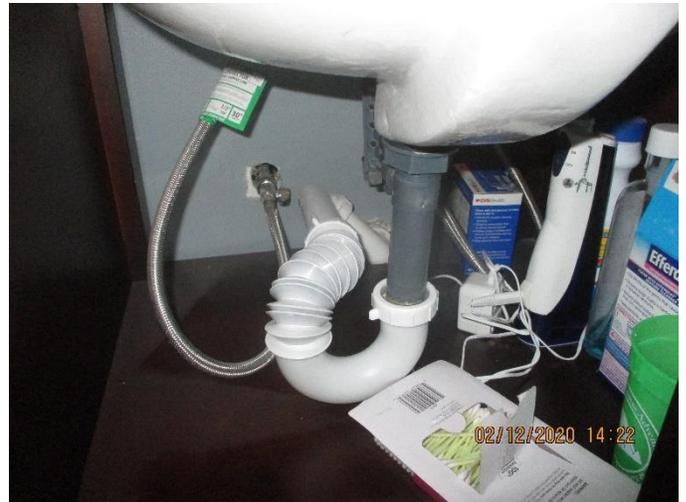
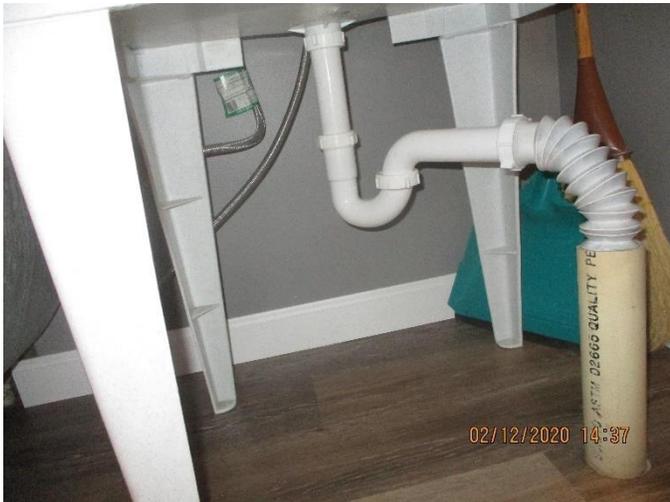
7. **Improve:** The drains for the sinks in the kitchen, master bedroom, and laundry room have been installed in a nonstandard fashion. This increases the potential for the development of clogs and improper drainage.

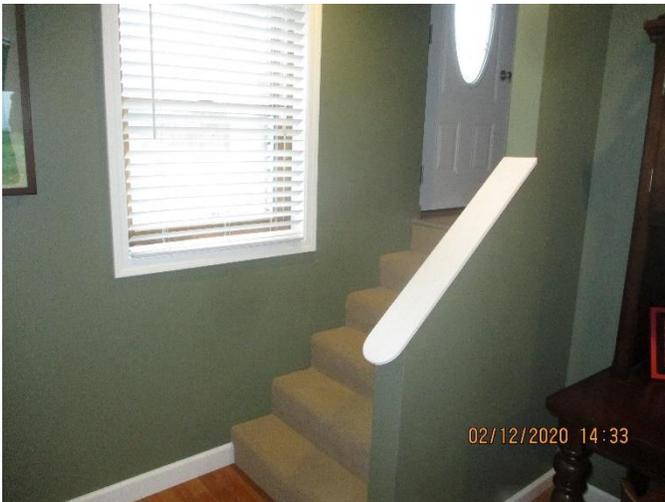
- 1. Safety Issue:** The window within the lower portion of the stairway represents a potential safety hazard. The glass does not appear to be tempered. This increases the potential for laceration. At a minimum, a guard railing should be provided to protect the window. Ideally, a tempered glass window would also be provided.

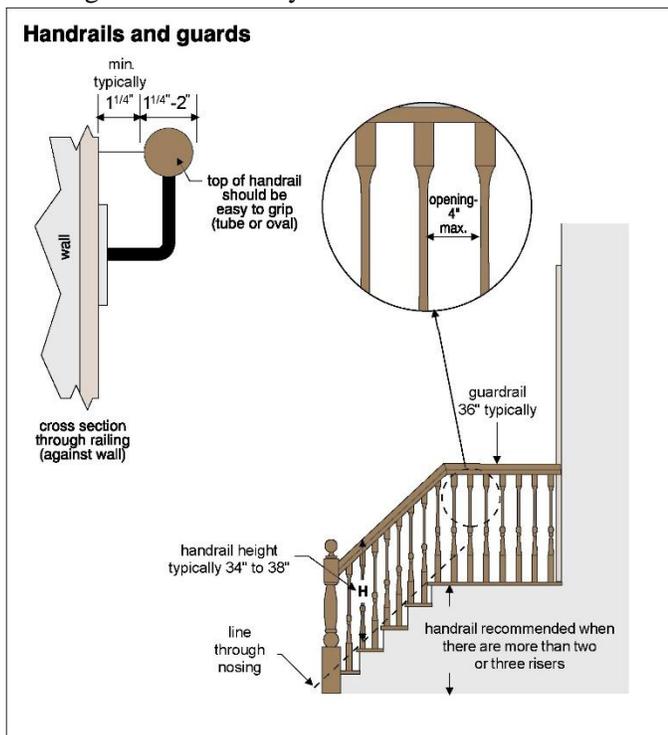
2. **Safety Issue:** For improved safety, it is recommended that graspable hand railings be provided for the entire length of the stairway.

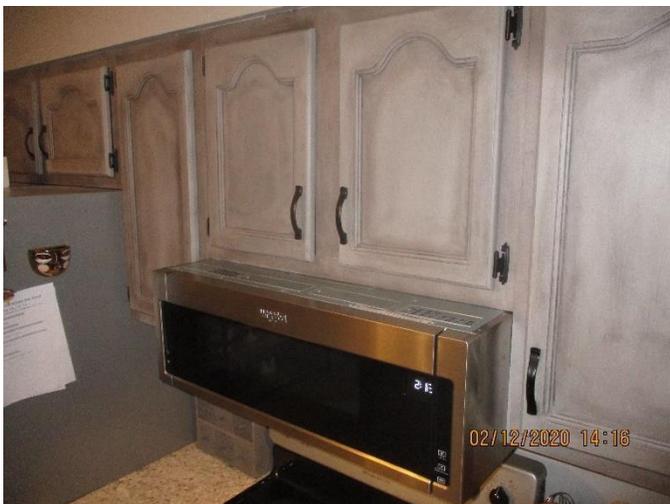
- 1. Investigate:** It is suspected the combination microwave and exhaust fan unit located above the range has not been installed as required by the manufacturer's installation instruction. The instructions should be evaluated to determine if modification or removal is necessary.

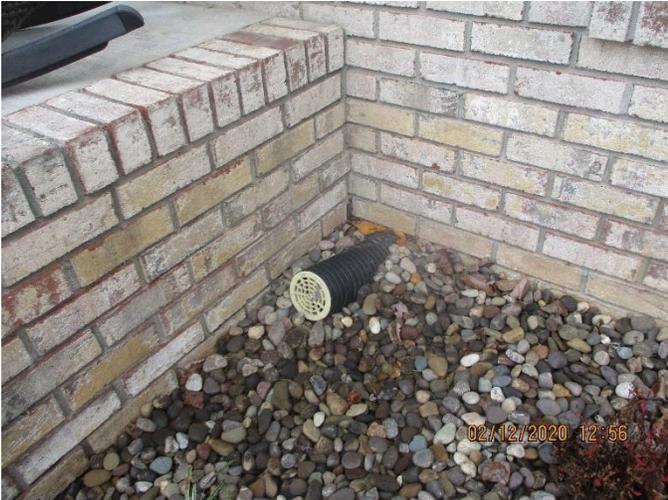
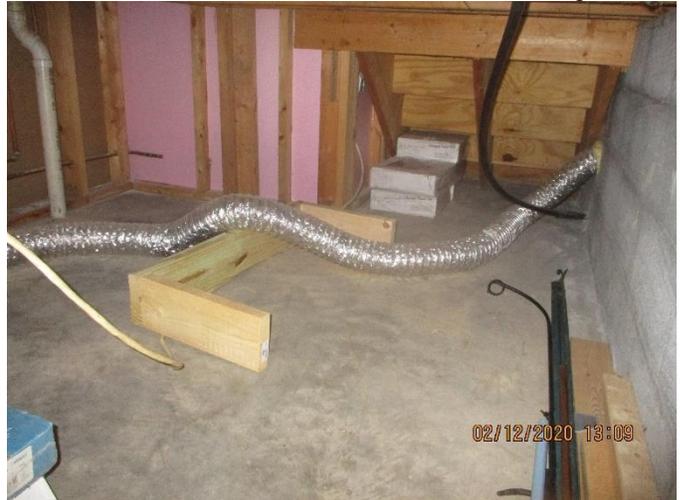
- 2. Safety Issue:** The clothes dryer is vented to the exterior of the building through aluminum foil duct and a corrugated drain pipe. These components are less safe and generally prohibited by typical clothes dryer manufacturer installation instruction. The installation of a smooth-wall metal vent is recommended.
